H. B. ROBINSON STEAM ELECTRIC PLANT, UNIT NO. 2
DOCKET NO. 50-261/LICENSE NO. DPR-23

LICENSEE EVENT REPORT NO. 2010-002-00
PLANT TRIP DUE TO ELECTRICAL FAULT

Plant Trip due to Electrical Fault

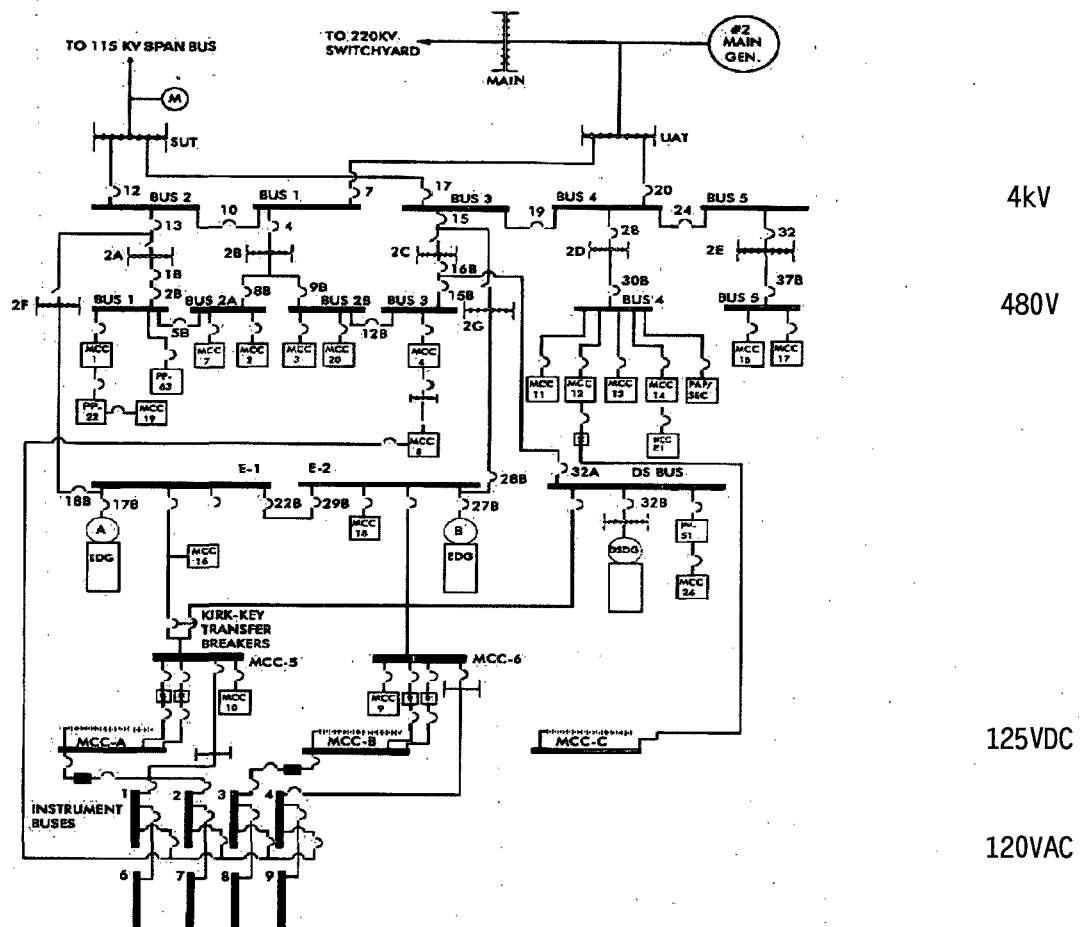
Figure 1 - Simplified Electrical Distribution

The following figure illustrates the electrical distribution system:
